Floodplain Management Study

Milton Creek Columbia County, Oregon

Technical Appendix

MILTON CREEK FLOODPLAIN MANGEMENT STUDY
TECHNICAL APPENDIX

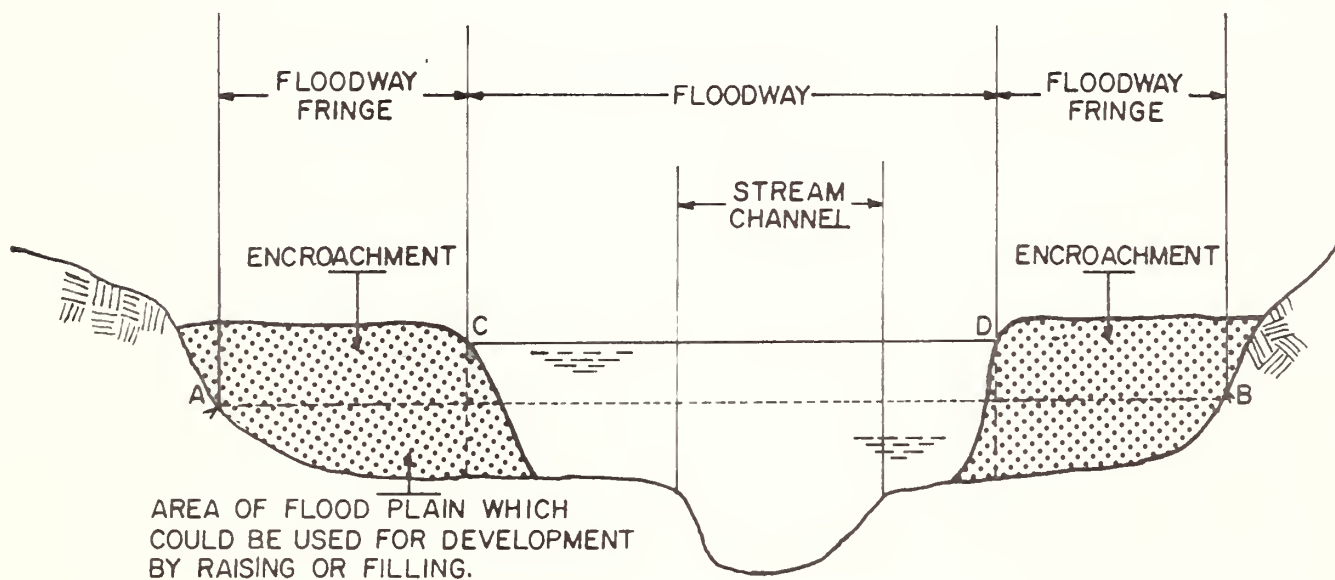
FIGURE 1

LINE A-B IS THE FLOOD ELEVATION BEFORE ENCROACHMENT
 LINE C-D IS THE FLOOD ELEVATION AFTER ENCROACHMENT

FLOODWAY RELATIONSHIPS

The area between the designated floodway and the boundary of the 100-year flood is called the "floodway fringe." No encroachment into the floodway should be allowed; however, building in the floodway fringe could be permitted if flood levels are above the 100-year flood elevation. Typical relationships between the floodway and the floodway fringe and their significance to floodplain development are shown on Figure 1.

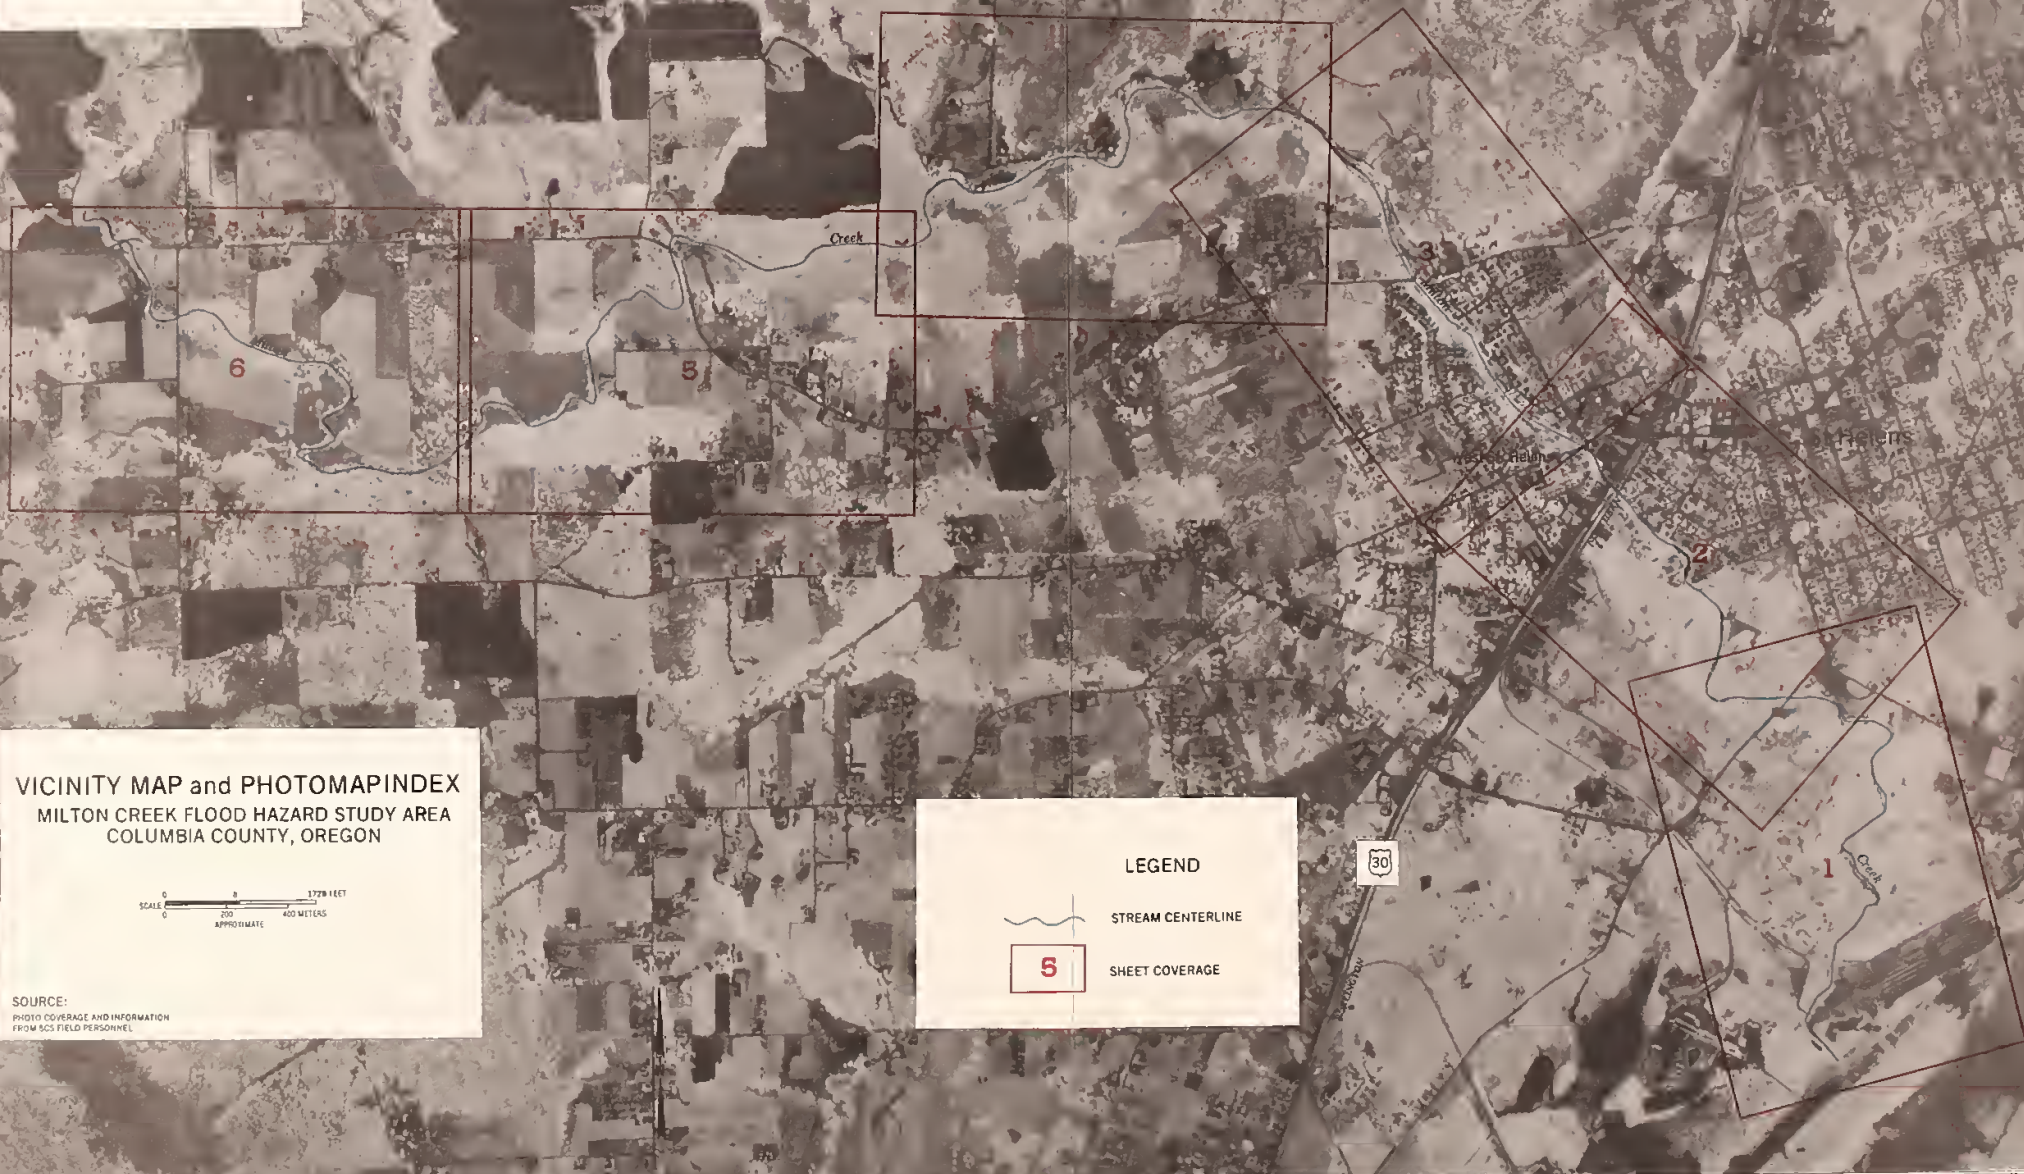
VICINITY MAP and PHOTOMAPINDEX
MILTON CREEK FLOOD HAZARD STUDY AREA
COLUMBIA COUNTY, OREGON

SCALE 0 1778 FEET
0 200 400 METERS
APPROXIMATE

SOURCE:
PHOTO COVERAGE AND INFORMATION
FROM SCS FIELD PERSONNEL

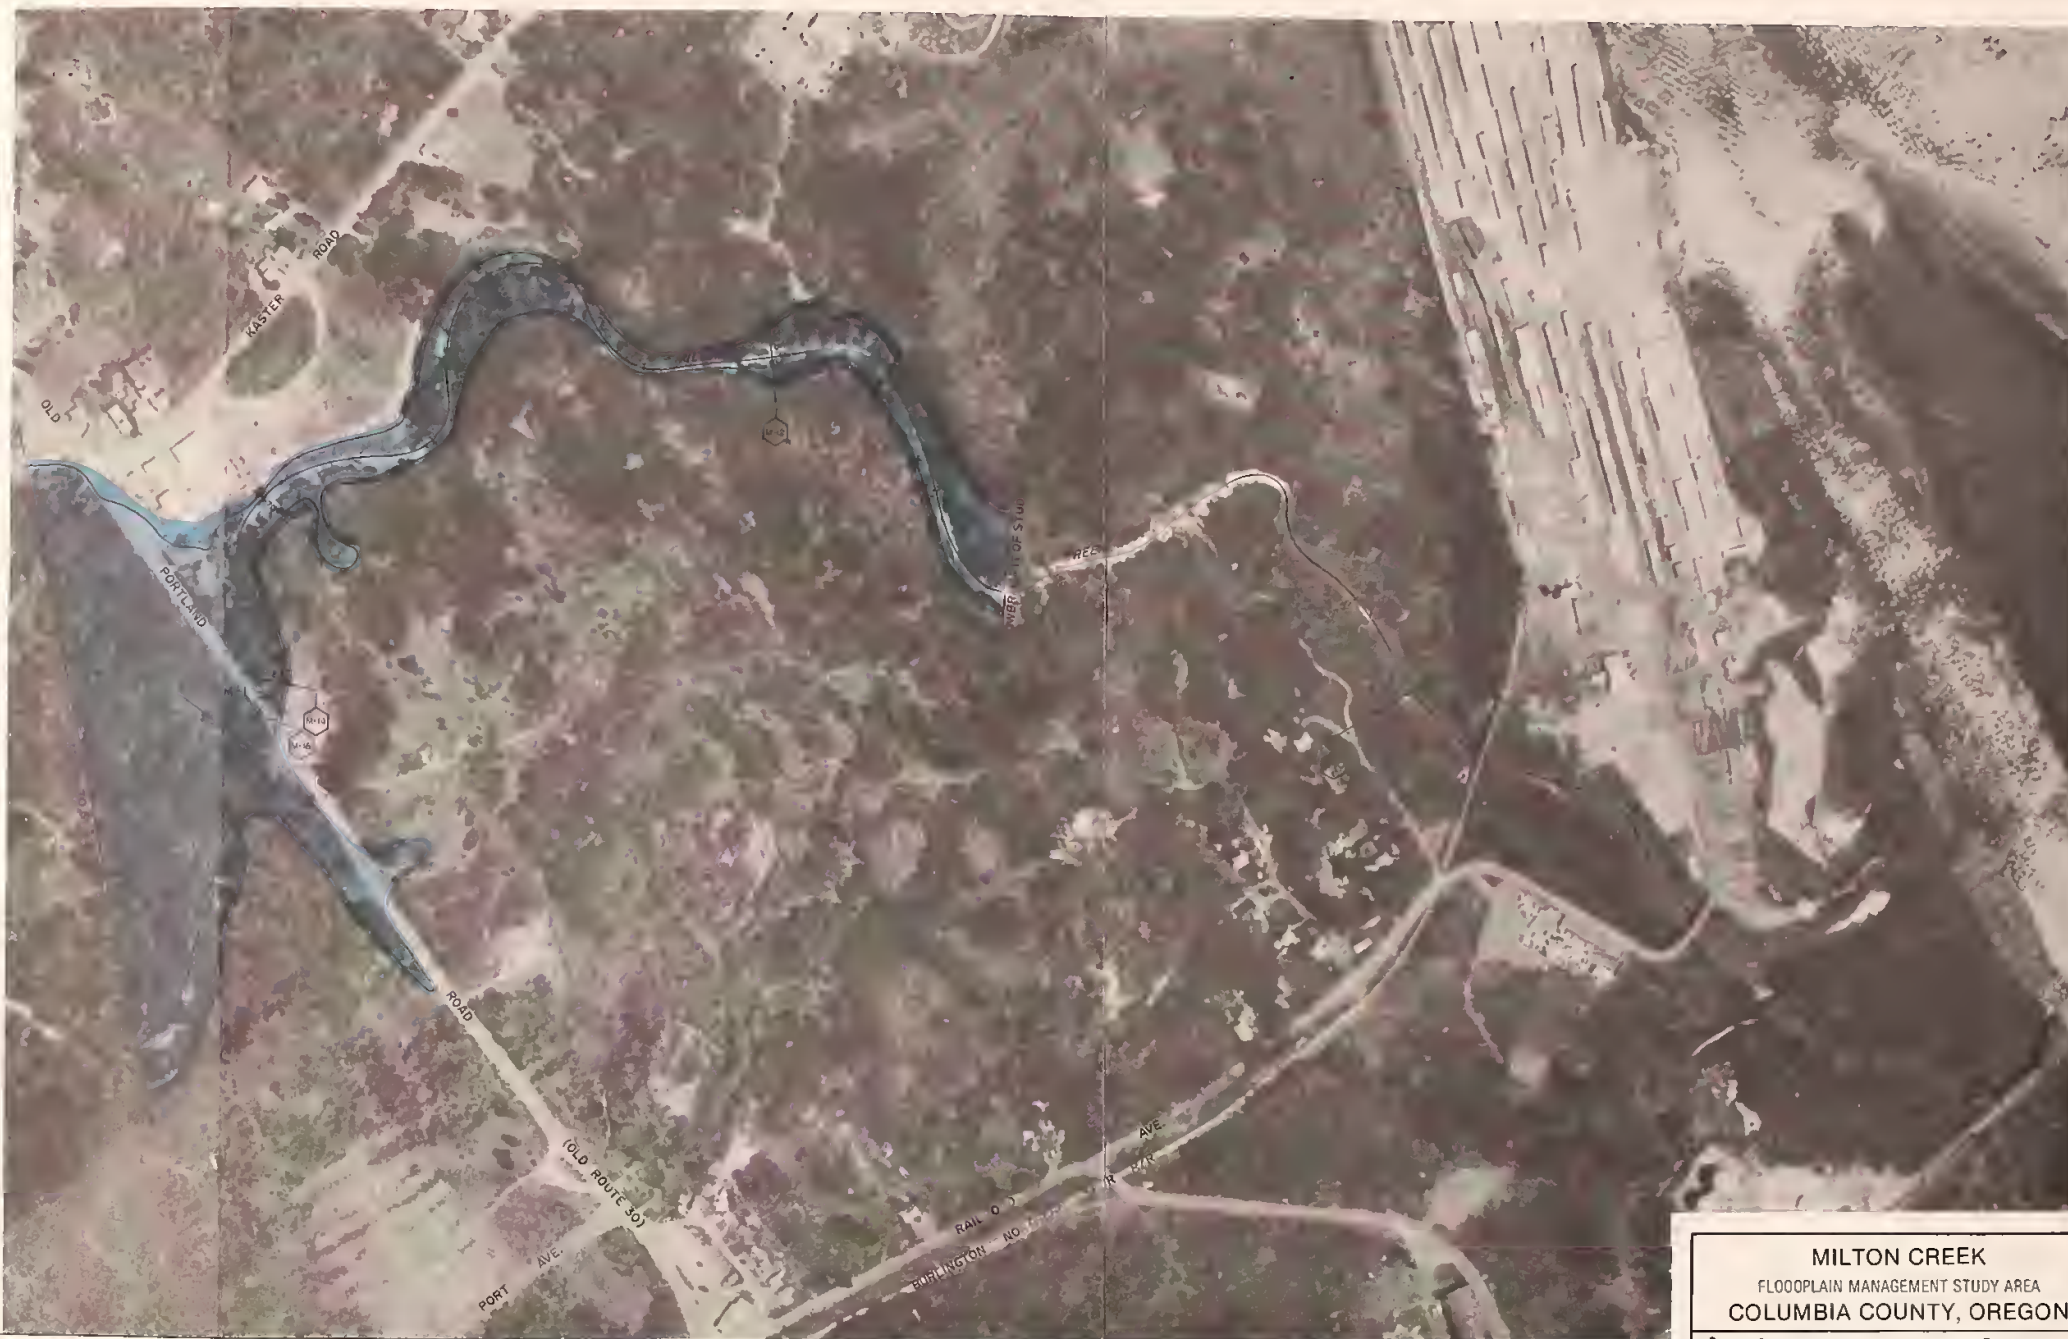
Designed.....	Date.....	Approved By.....
Drawn.....	Title.....	
Traced.....	Sheet No. 1	Drawing No.
Checked.....	at 10	March 1984 4-R-38512

MILTON CREEK
 FLOODPLAIN MANAGEMENT STUDY AREA
 COLUMBIA COUNTY, OREGON

Flood hazard photomaps of the Milton Creek study area are reproduced in Attachment 2. These photomaps are the same maps as included in the Report, Appendix B, with the addition of a proposed floodway. The photomaps show the area inundated by the 100-year and 500-year floods. In the places where only the 100-year floodplain is indicated, the line represents both the 100-year and 500-year floodplains. This is because the two floodplains are so close together that only one line could be shown on the drawings. The floodway is shown on the photomap, sheets 2, 3 and 6. The flood elevations were computed at each cross-section and the elevation between cross-sections has been interpolated. After computing the flood elevations, the outline of the floodplain was developed in the field. It is possible that small local islands exist within the floodplain and are not shown on the photomaps. Some slight flooding may occur outside the designated floodplain due to concentrated local runoff from adjacent areas. To determine the flooding potential at a specific location, a field survey would be required using the computed or interpolated flood elevations.

Each of the surveyed cross-sections and available reference (benchmarks) marks are located on the photomaps. The elevation of the 100-year flood is given at each cross-section on the maps.

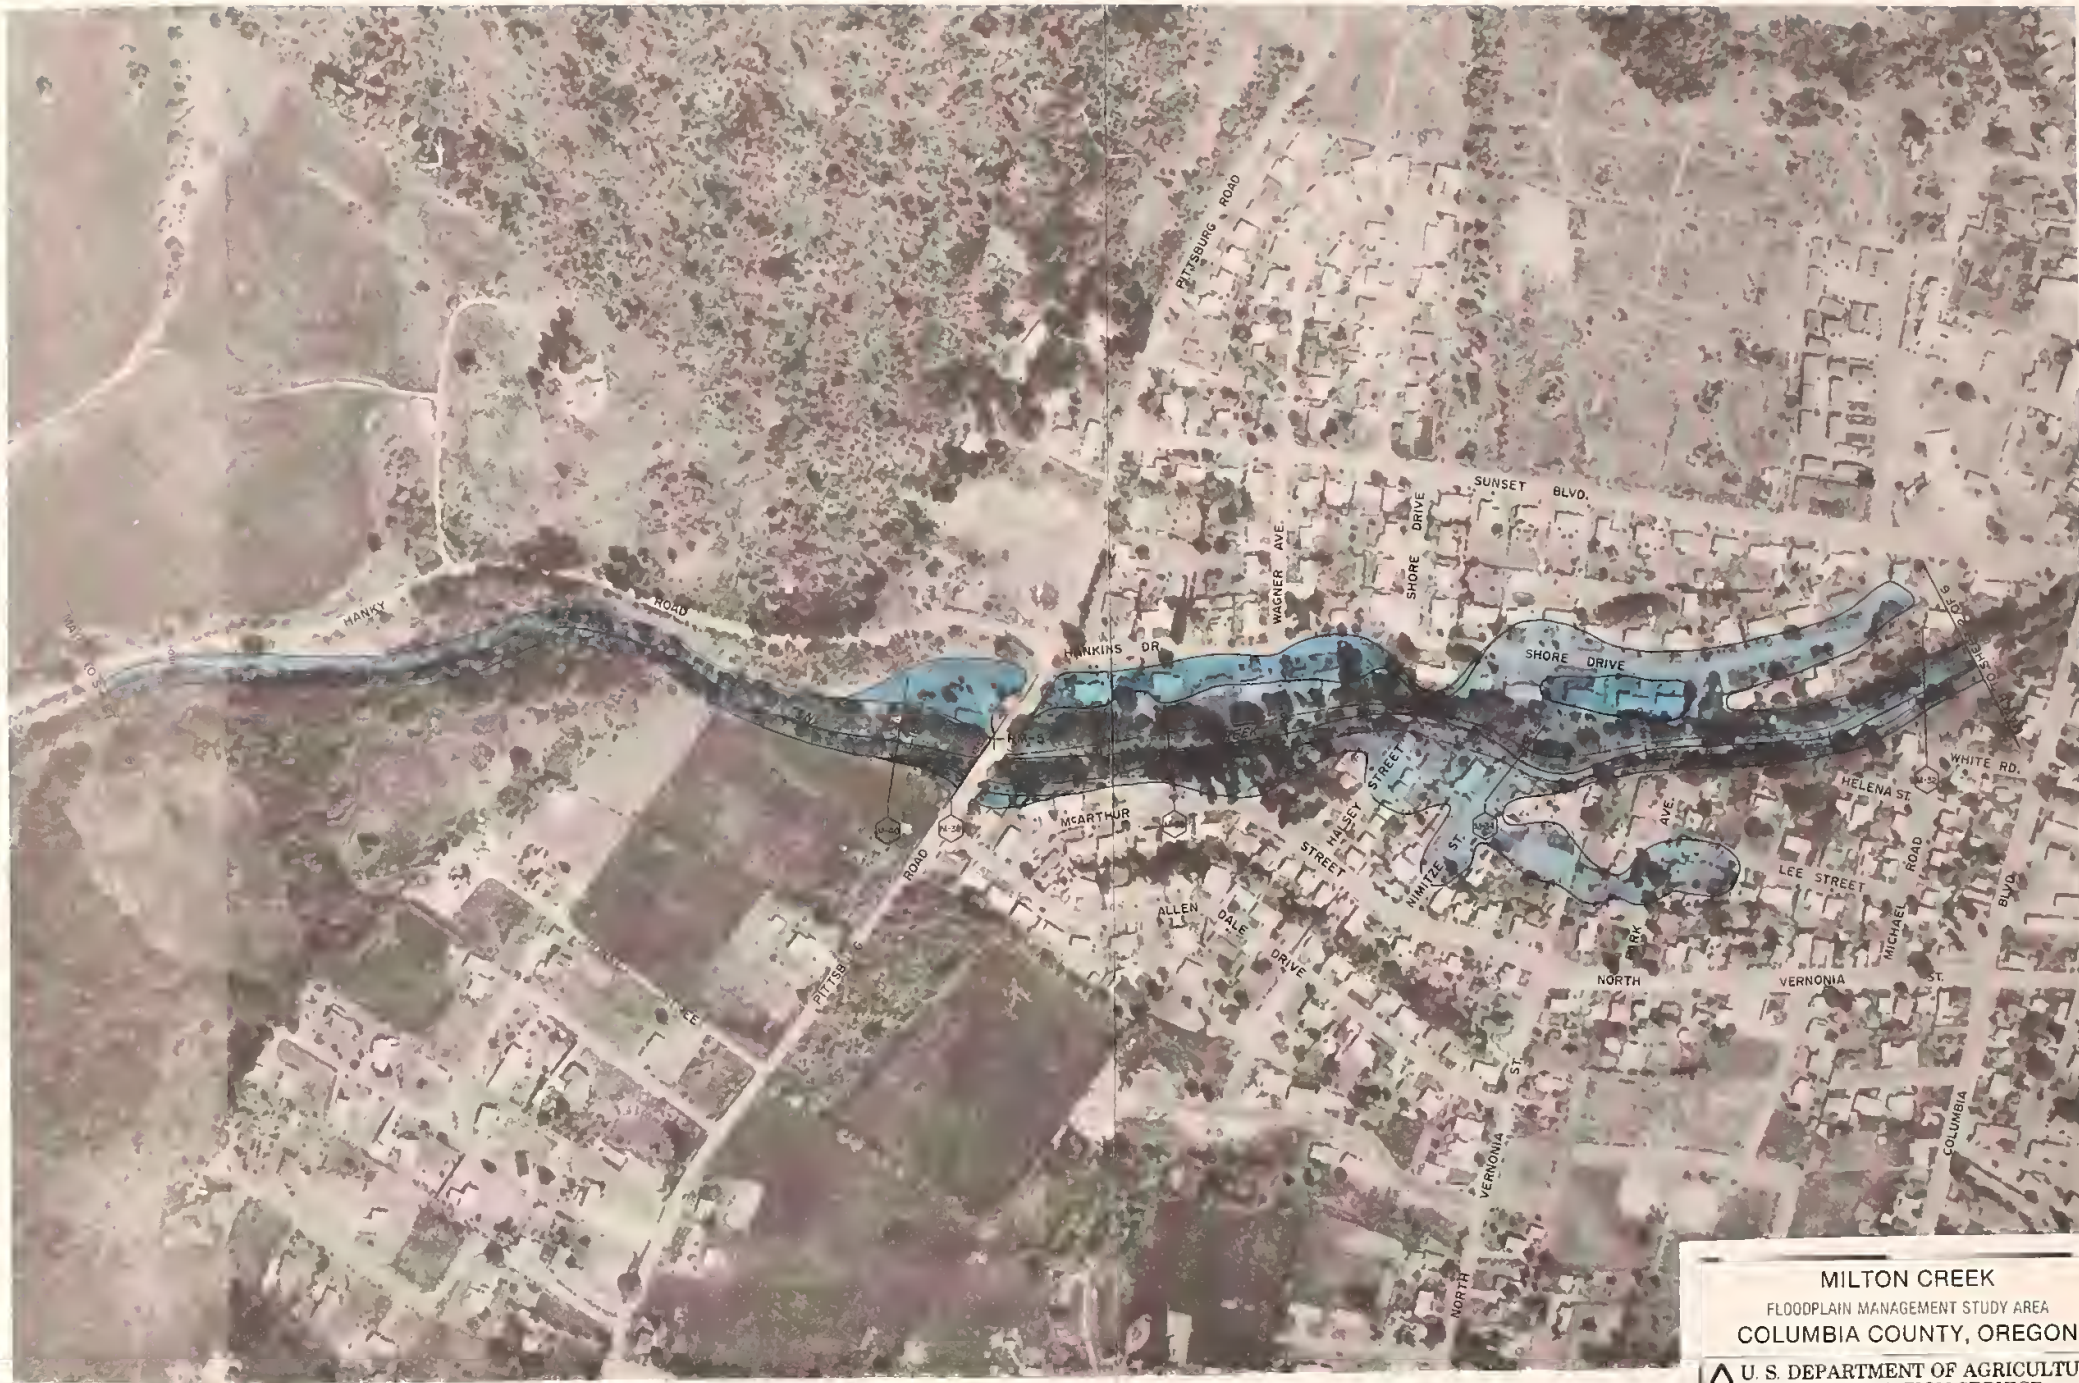
Designed	Date	Approved By	Title
Drawn			
Traced			
Checked			
		Drawing No.	March 1964 4-R-38512

MILTON CREEK FLOODPLAIN MANAGEMENT STUDY AREA COLUMBIA COUNTY, OREGON

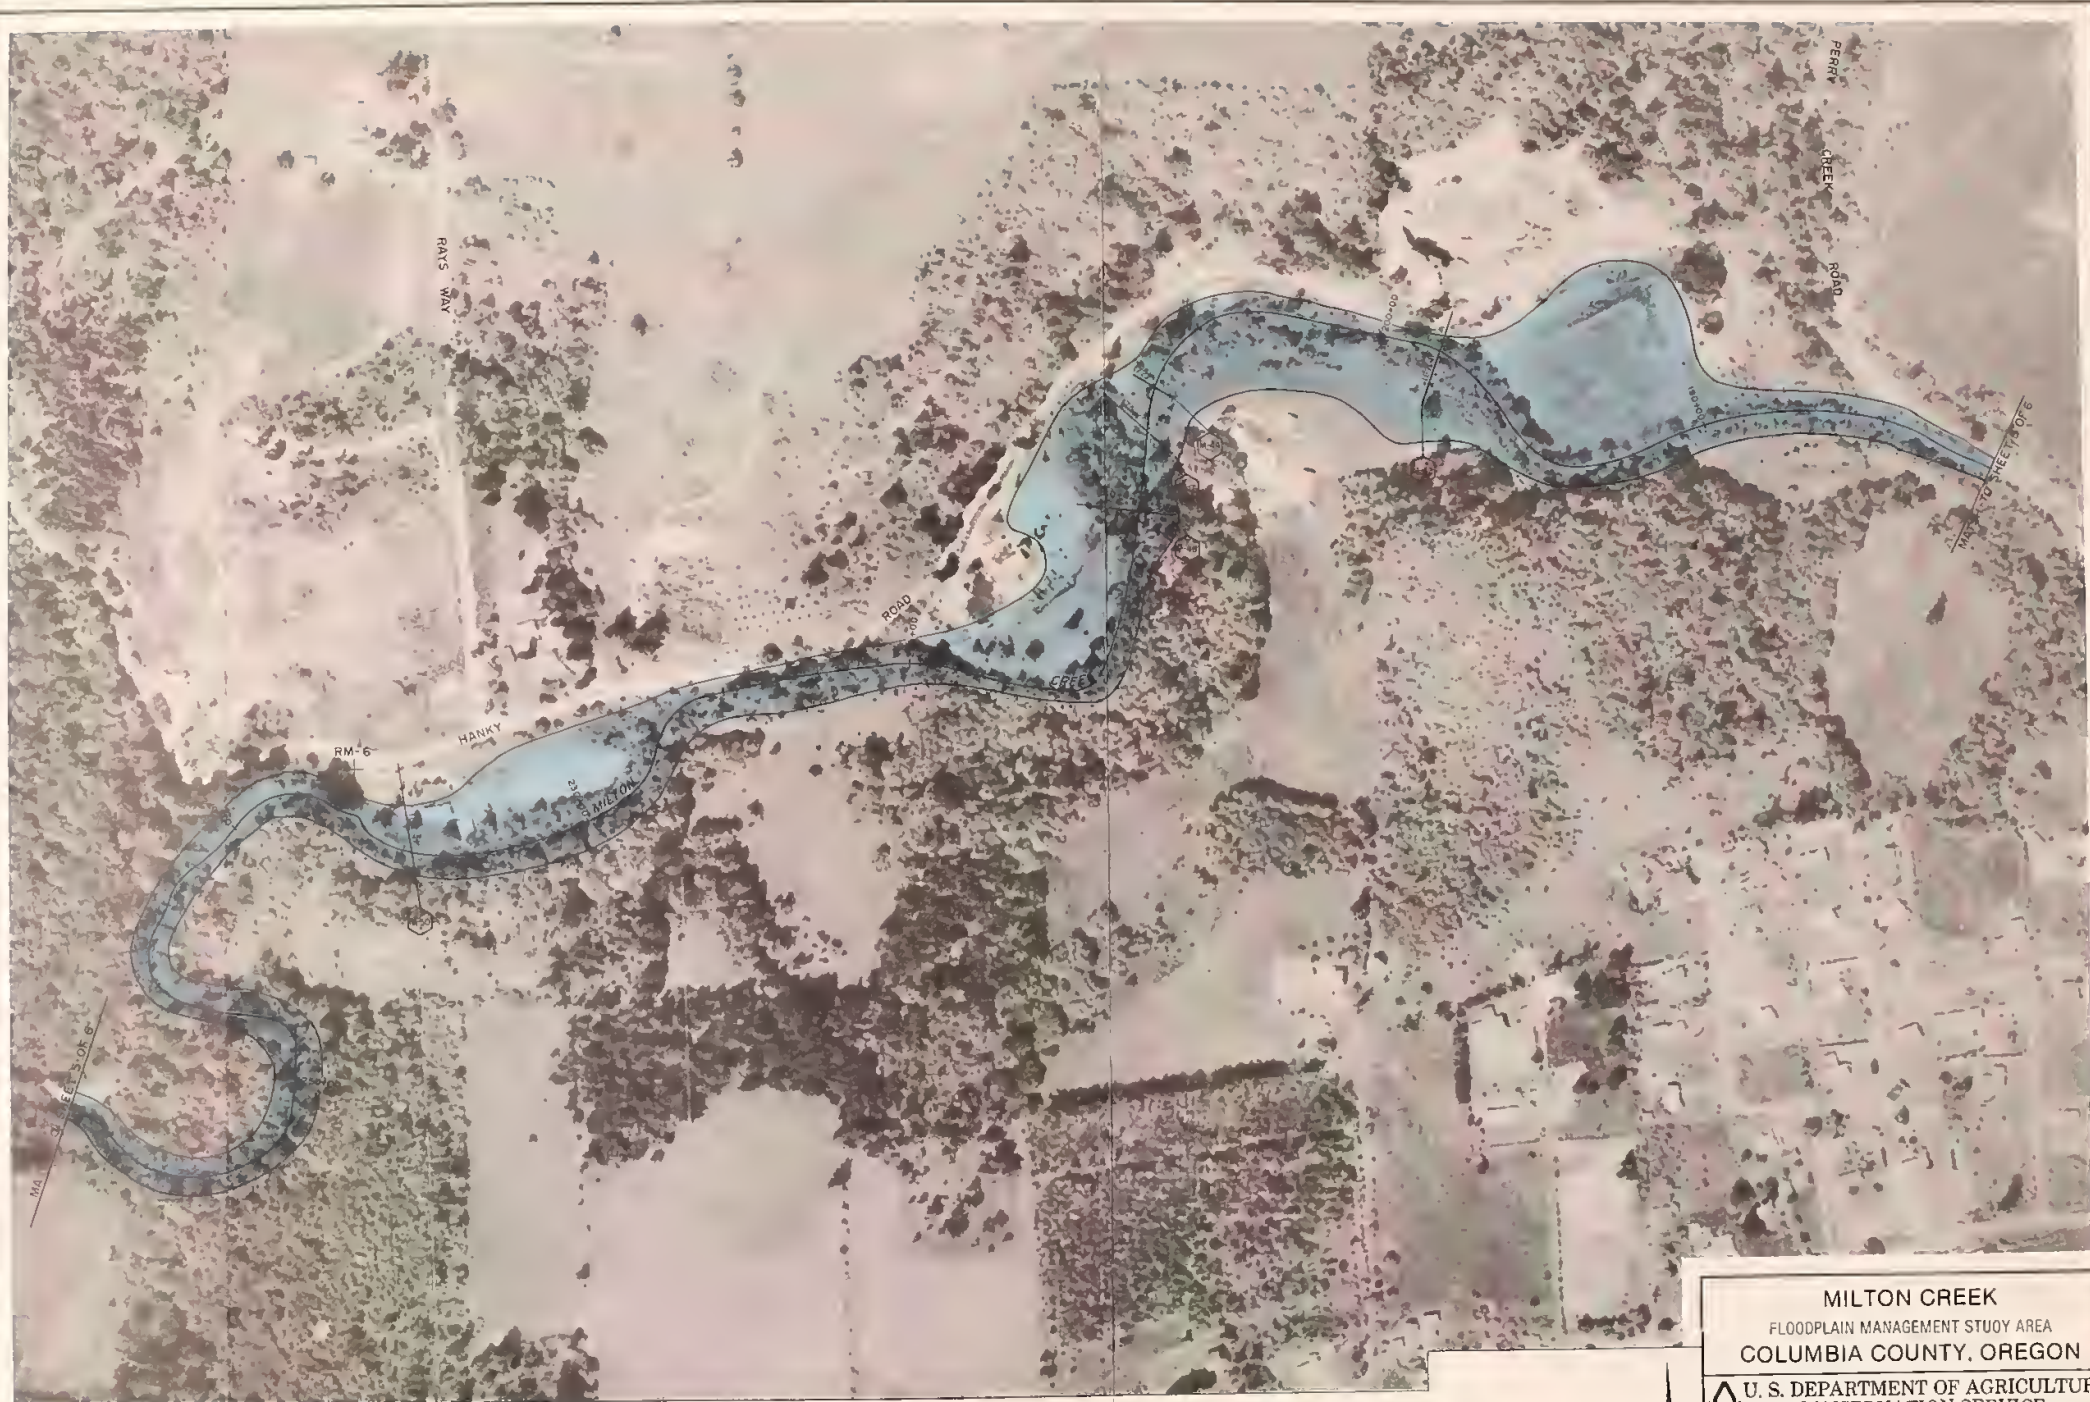
Designed by	Drawn by	Traced by	Checked by
Approved by	Title	Sheet No. 4	Drawing No. March 1984 4 R-38512

MILTON CREEK FLOODPLAIN MANAGEMENT STUDY AREA COLUMBIA COUNTY, OREGON

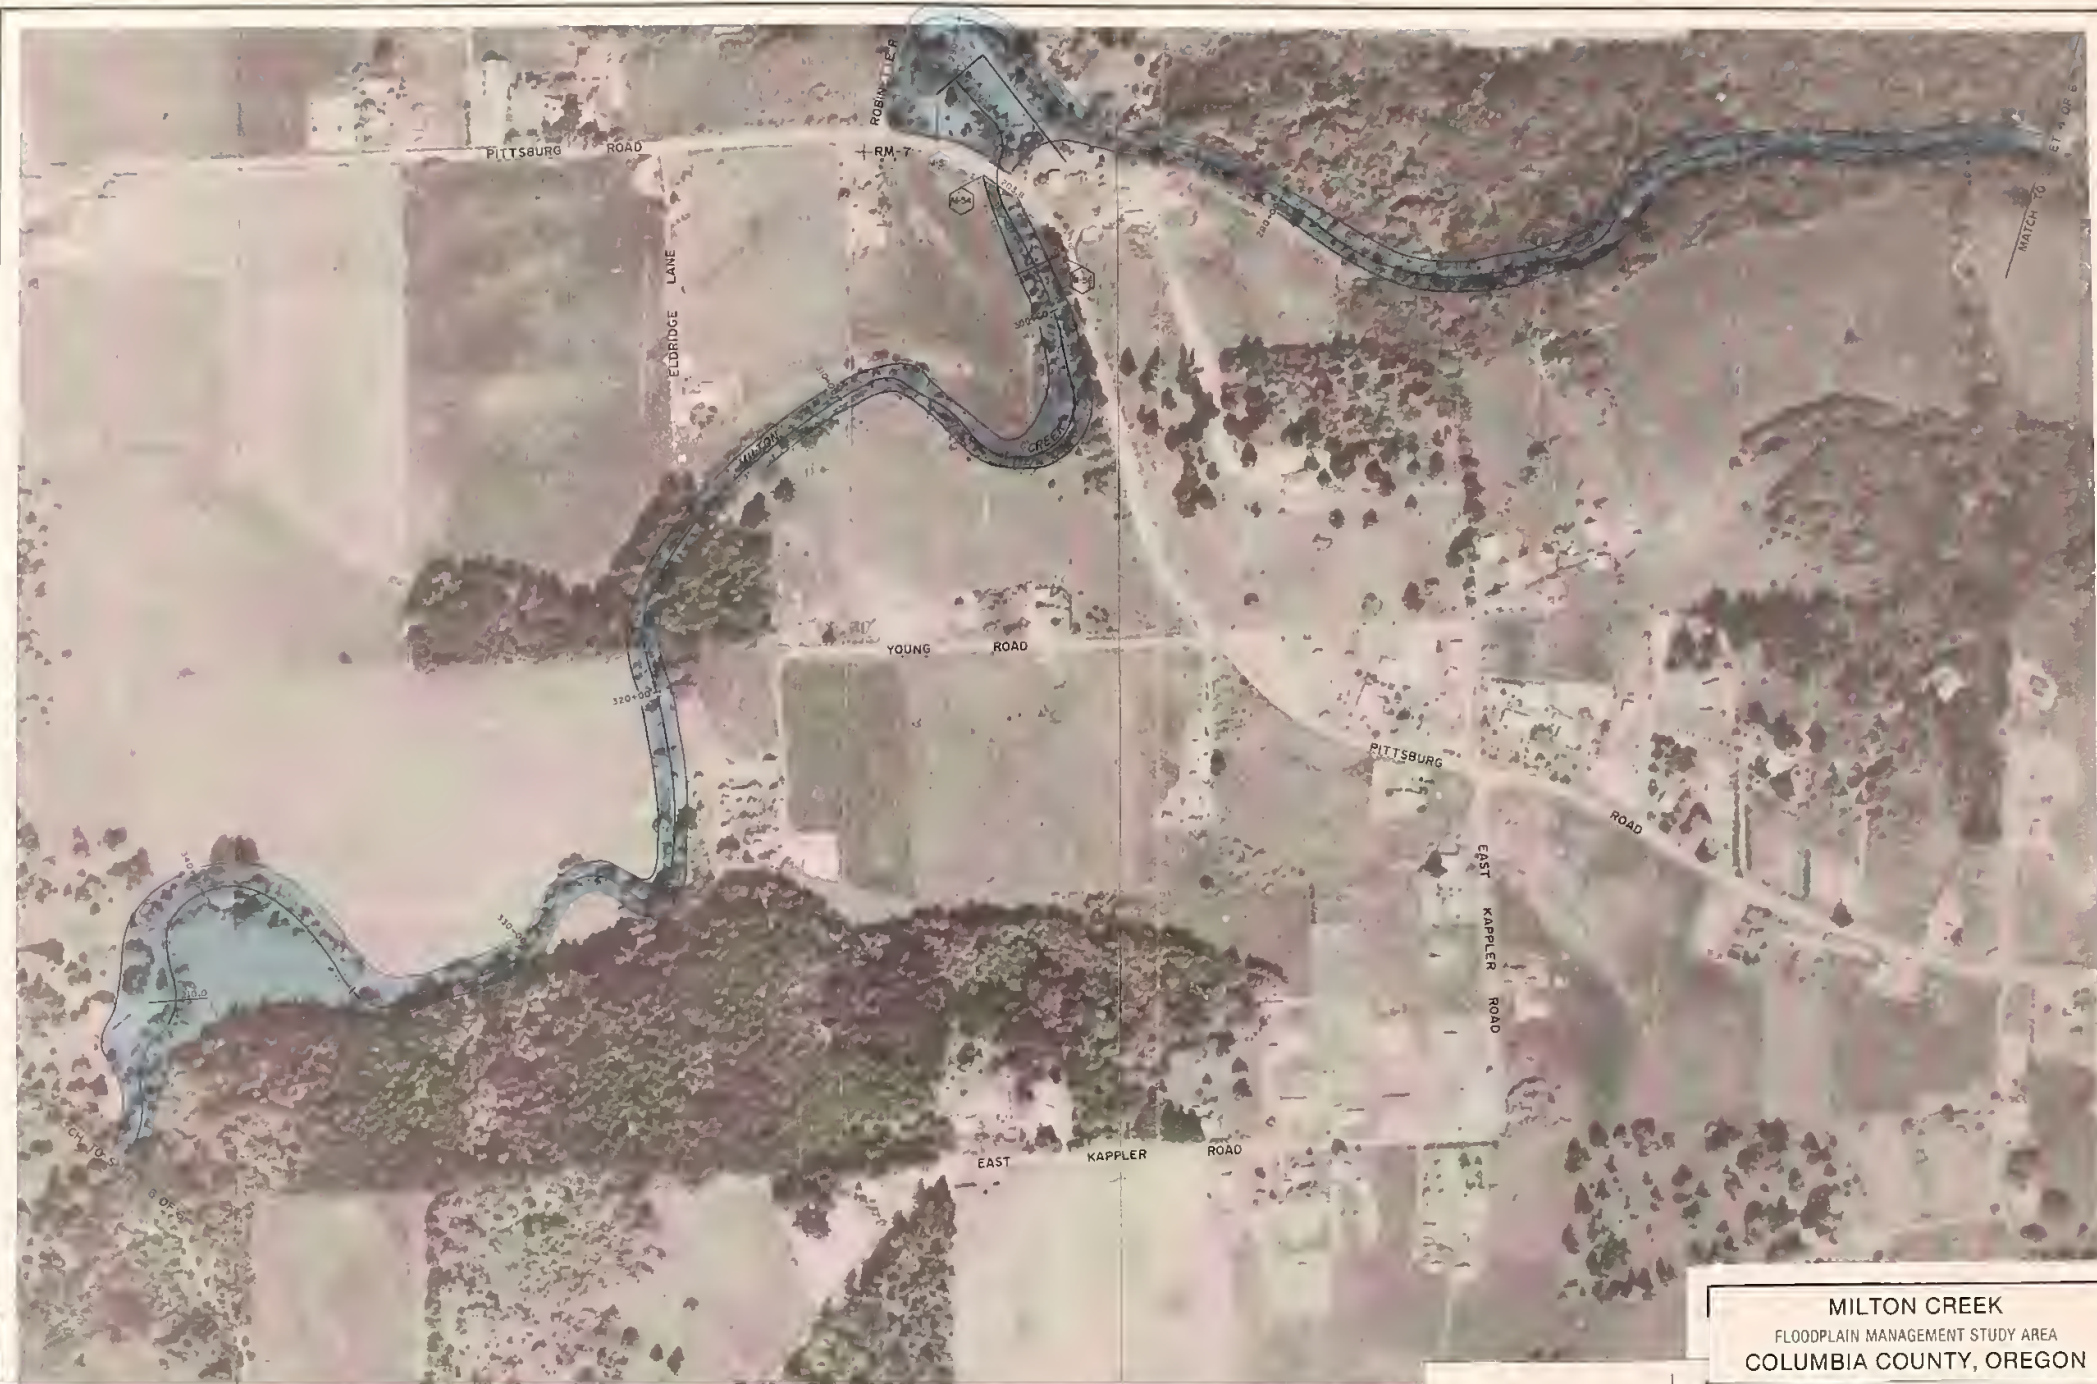
Designed.....	Date.....	Approved By.....
Drawn.....	Title.....	
Tracked.....	Scale.....	Drawing No.....
Checked.....	Sheet No. 5 of 6	March 1984 4-R-35512

MILTON CREEK
FLOODPLAIN MANAGEMENT STUDY AREA
COLUMBIA COUNTY, OREGON

- 100-YEAR FLOOD BOUNDARY
- 500-YEAR FLOOD BOUNDARY
- LINE OF STREAMFLOW WITH STATIONING
- CROSS SECTION WITH 100 YEAR FLOOD ELEV.
- RM-2 BENCH MARK

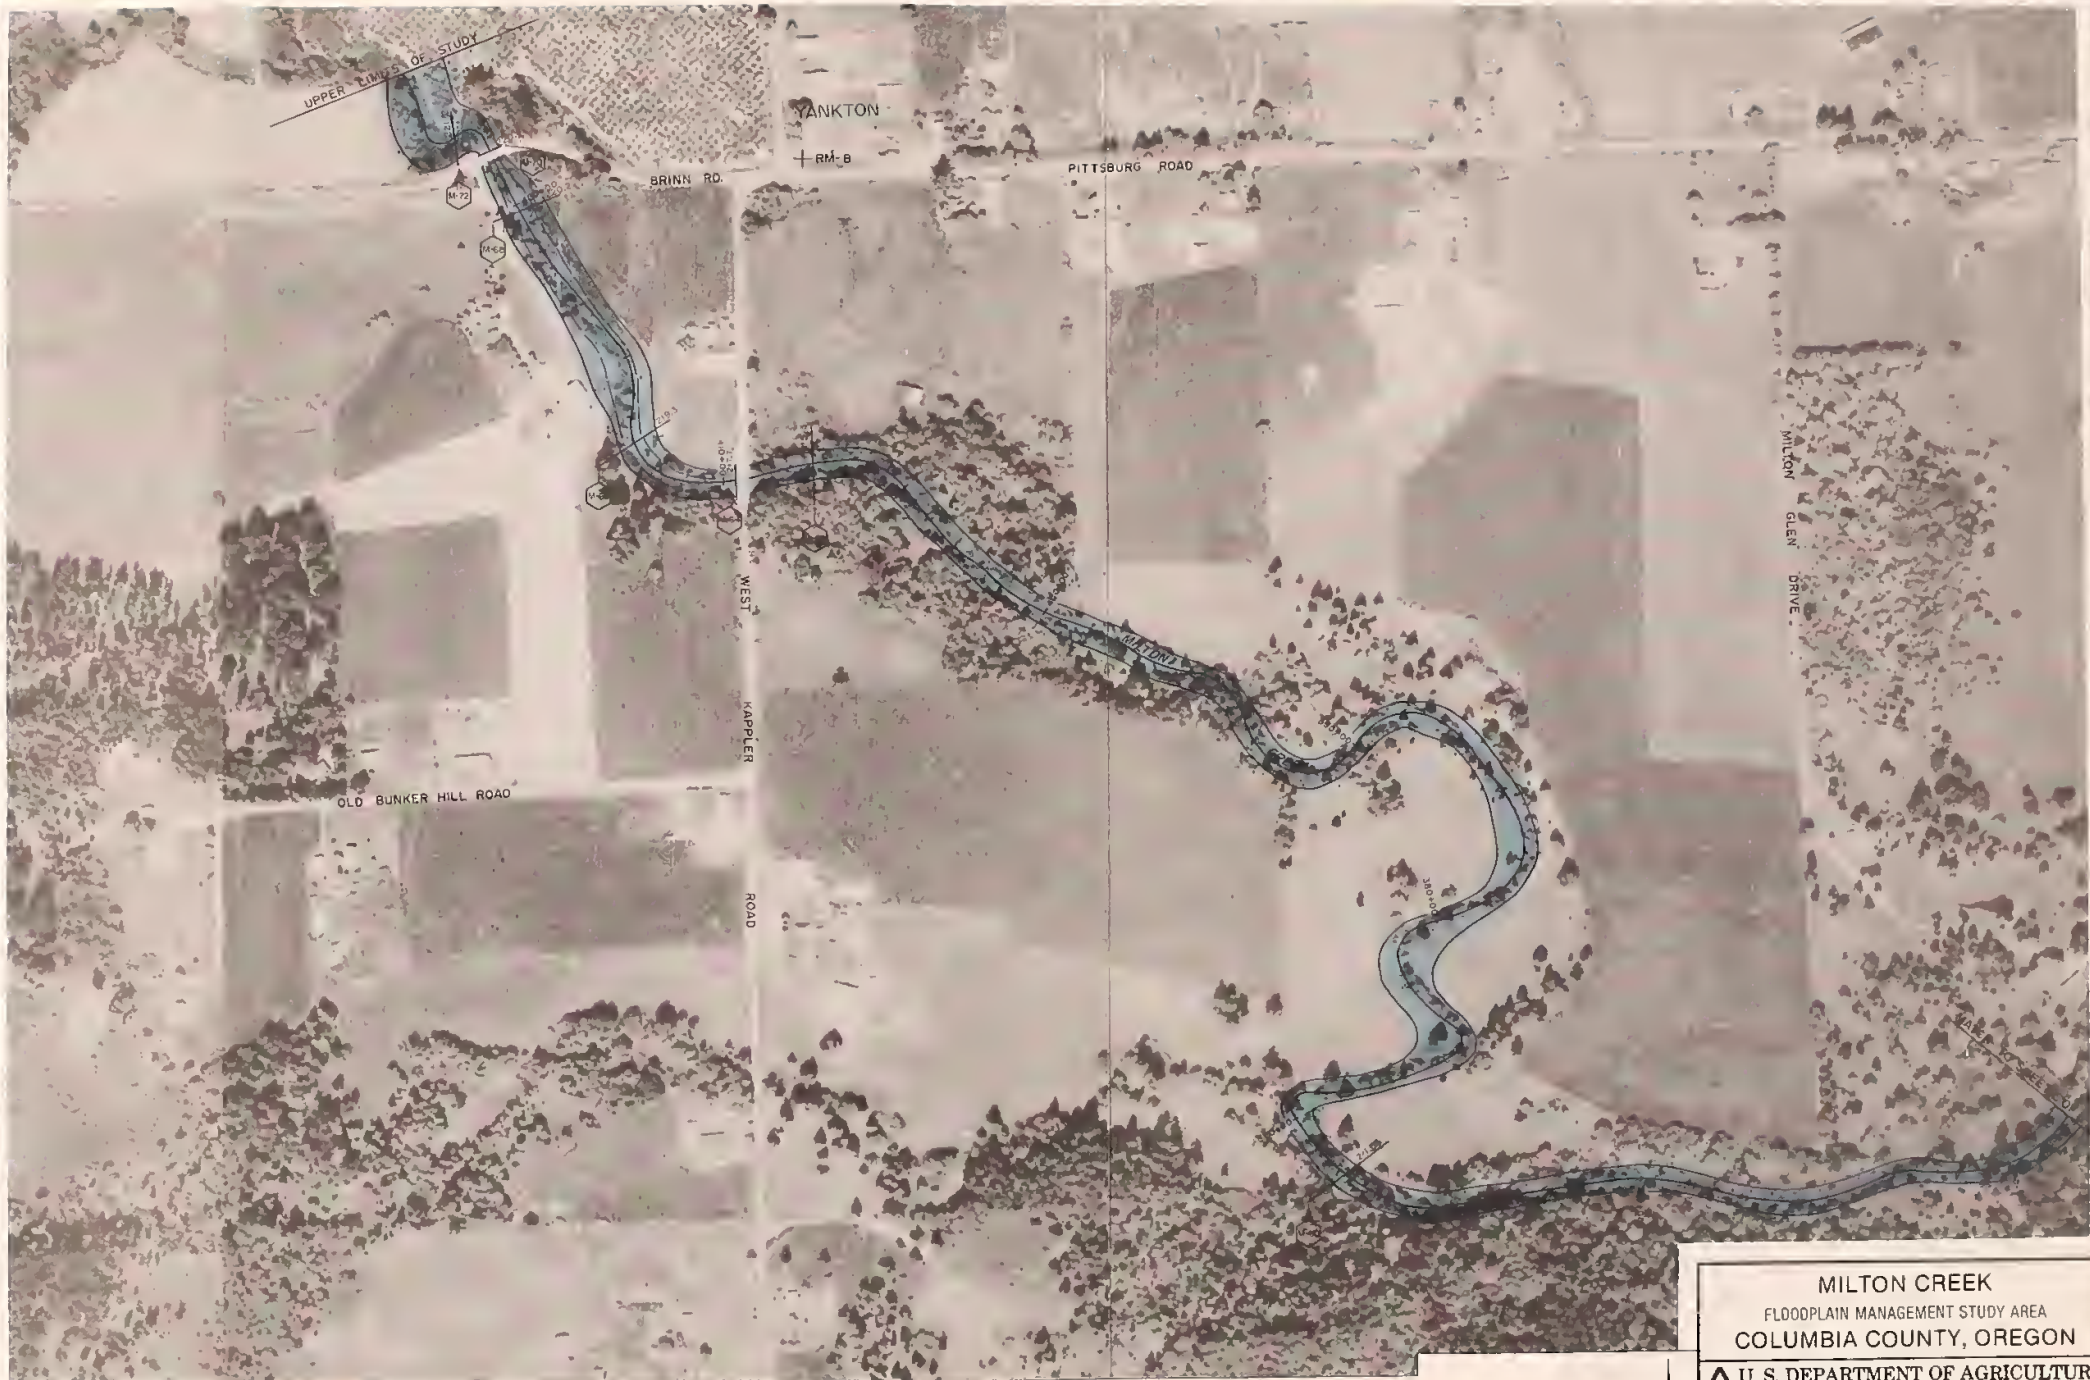
Designed.....	Date.....	Approved By.....
Drawn.....	Title.....	
Traced.....	Sheet No. 6	Drawn No. 6
Checked.....	March 1984	4 R-38512

MILTON CREEK FLOODPLAIN MANAGEMENT STUDY AREA COLUMBIA COUNTY, OREGON

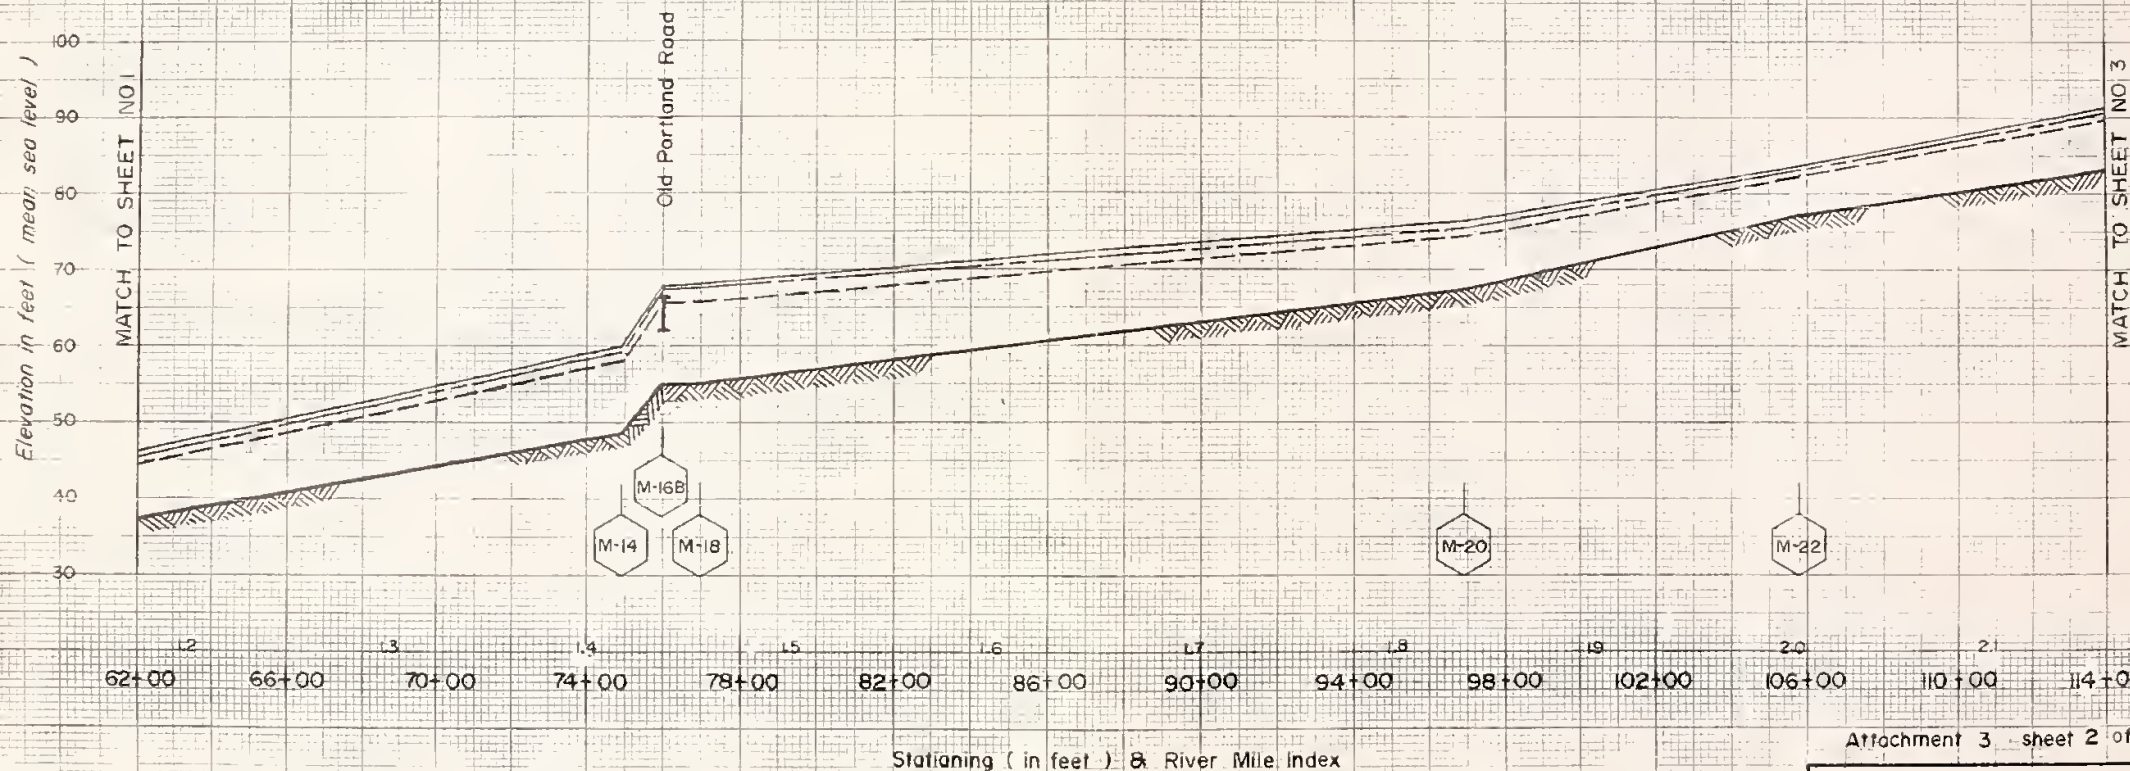
Attachment 3 sheet 2 of 8

PROFILE

FLOODPLAIN MANAGEMENT STUDY

Flood profiles are presented in Attachment 3. The profiles show the river bottom, and the 10-, 100-, and 500-year flood elevations. Cross-section locations and their stationing are shown. The river mile index is also shown on the profiles. The profile will give an indication of the depth of flooding at the deepest point on each surveyed cross-section and the slope of the flow lines. The bridges in the study are located on the profiles.

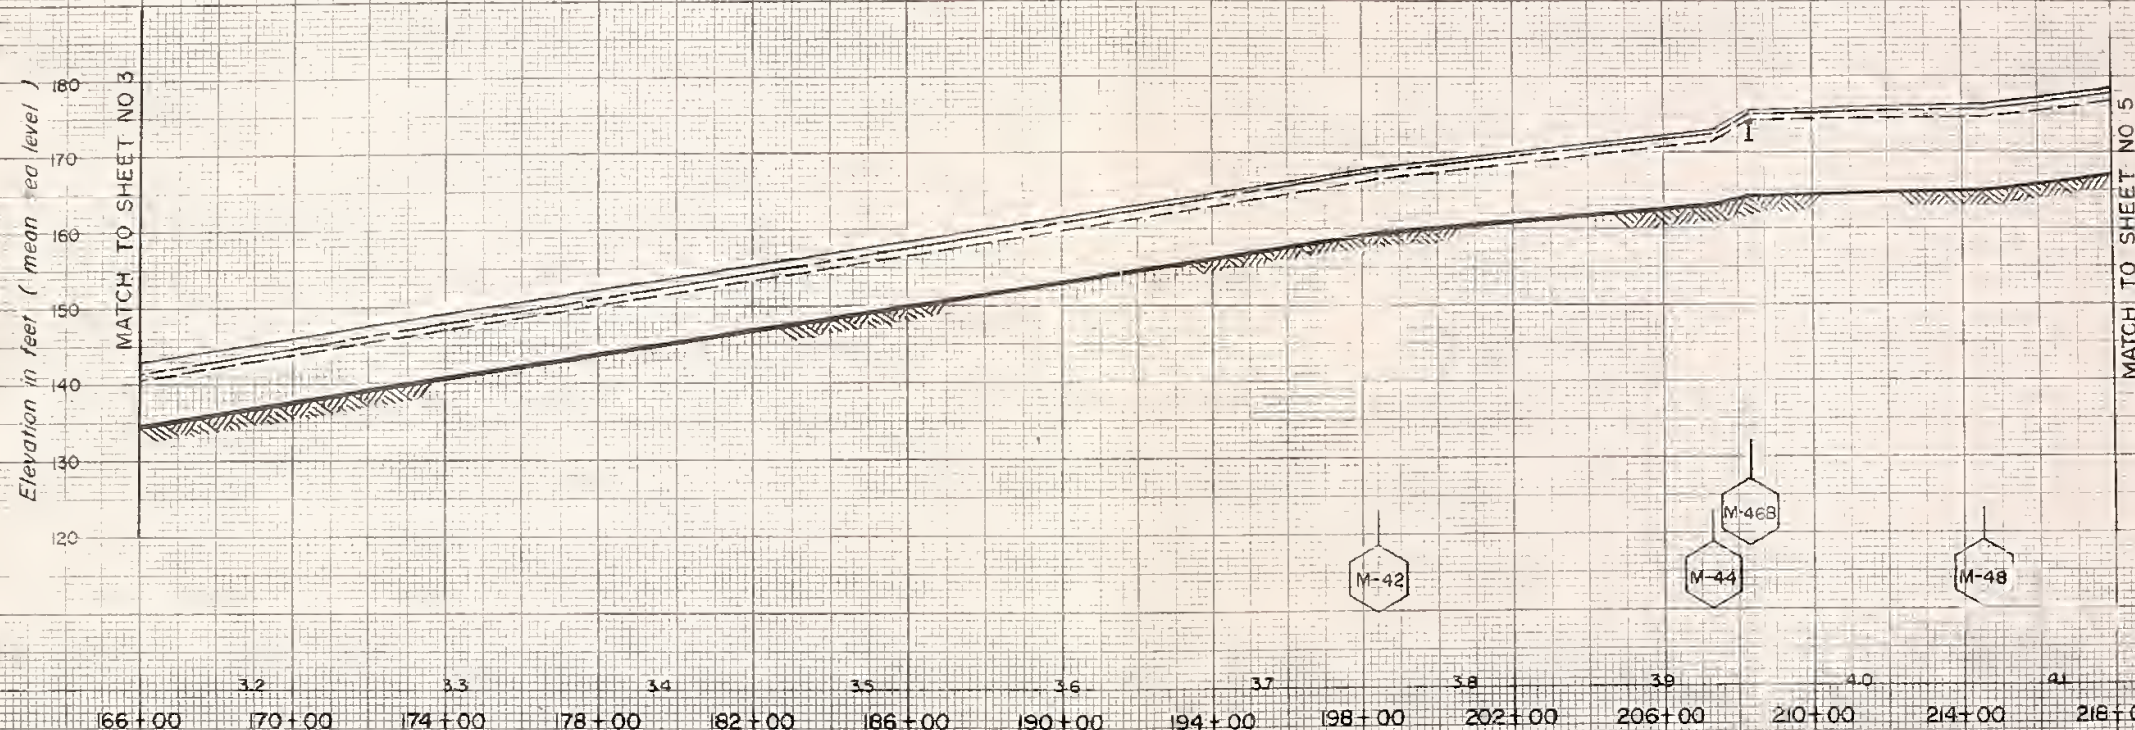
Attachment 3 sheet 4 of 8

PROFILE
FLOODPLAIN MANAGEMENT STUDY
MILTON CREEK
COLUMBIA COUNTY, OREGON
